**Table of Contents for Block at 26<sup>th</sup> street**  
**Heritage Tree Variance Package**

**PROJECT NAME:** Block at 26<sup>th</sup> Street

**REQUEST:** The applicant is requesting to remove a heritage tree with a stem greater than 30 inches as allowed under LDC 25-8-643

**SUBJECT:** Block at 26<sup>th</sup> Street  
SP-2011-0032C.SH

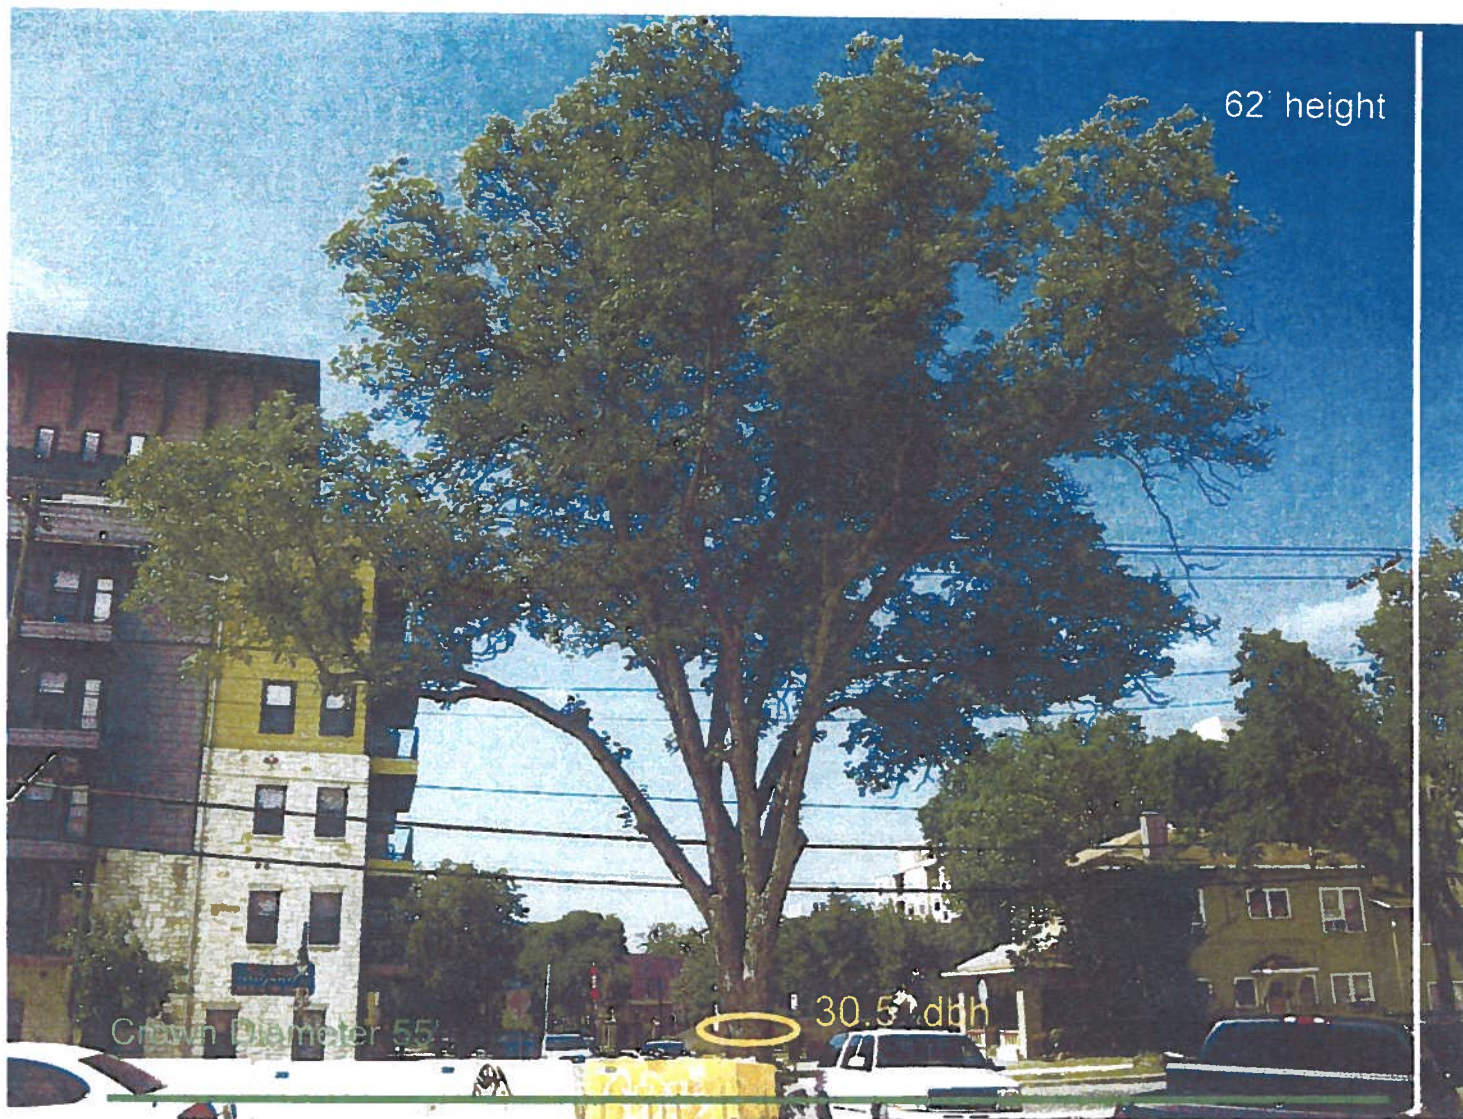
Exhibit #2

The subject tree is a 30.5 inch diameter at breast height (dbh) Pecan (*Carya illinoensis*). The tree height is 63 feet and the canopy spread is 55 feet (Exhibit 2). The trunk bifurcates into two co-dominate stems at eight feet above grade (Exhibit 3). Storm damage is evident by the presence of broken stems, though no noticeable decay or structural weaknesses are present (Exhibit 4). Minor pruning has occurred for utility clearing and likely from storm damage. There is minor deadwood and tip dieback in the crown though this is not uncommon in *Carya illinoensis* (Exhibit 5). This condition is likely exacerbated by poor soil and extensive compaction in the critical root zone (Exhibit 6). Given the aforementioned conditions, the subject tree is rated 'good' per the City Arborist tree evaluation (Exhibit 7).

62' height

Crown Diameter 55'

30.5' dbh

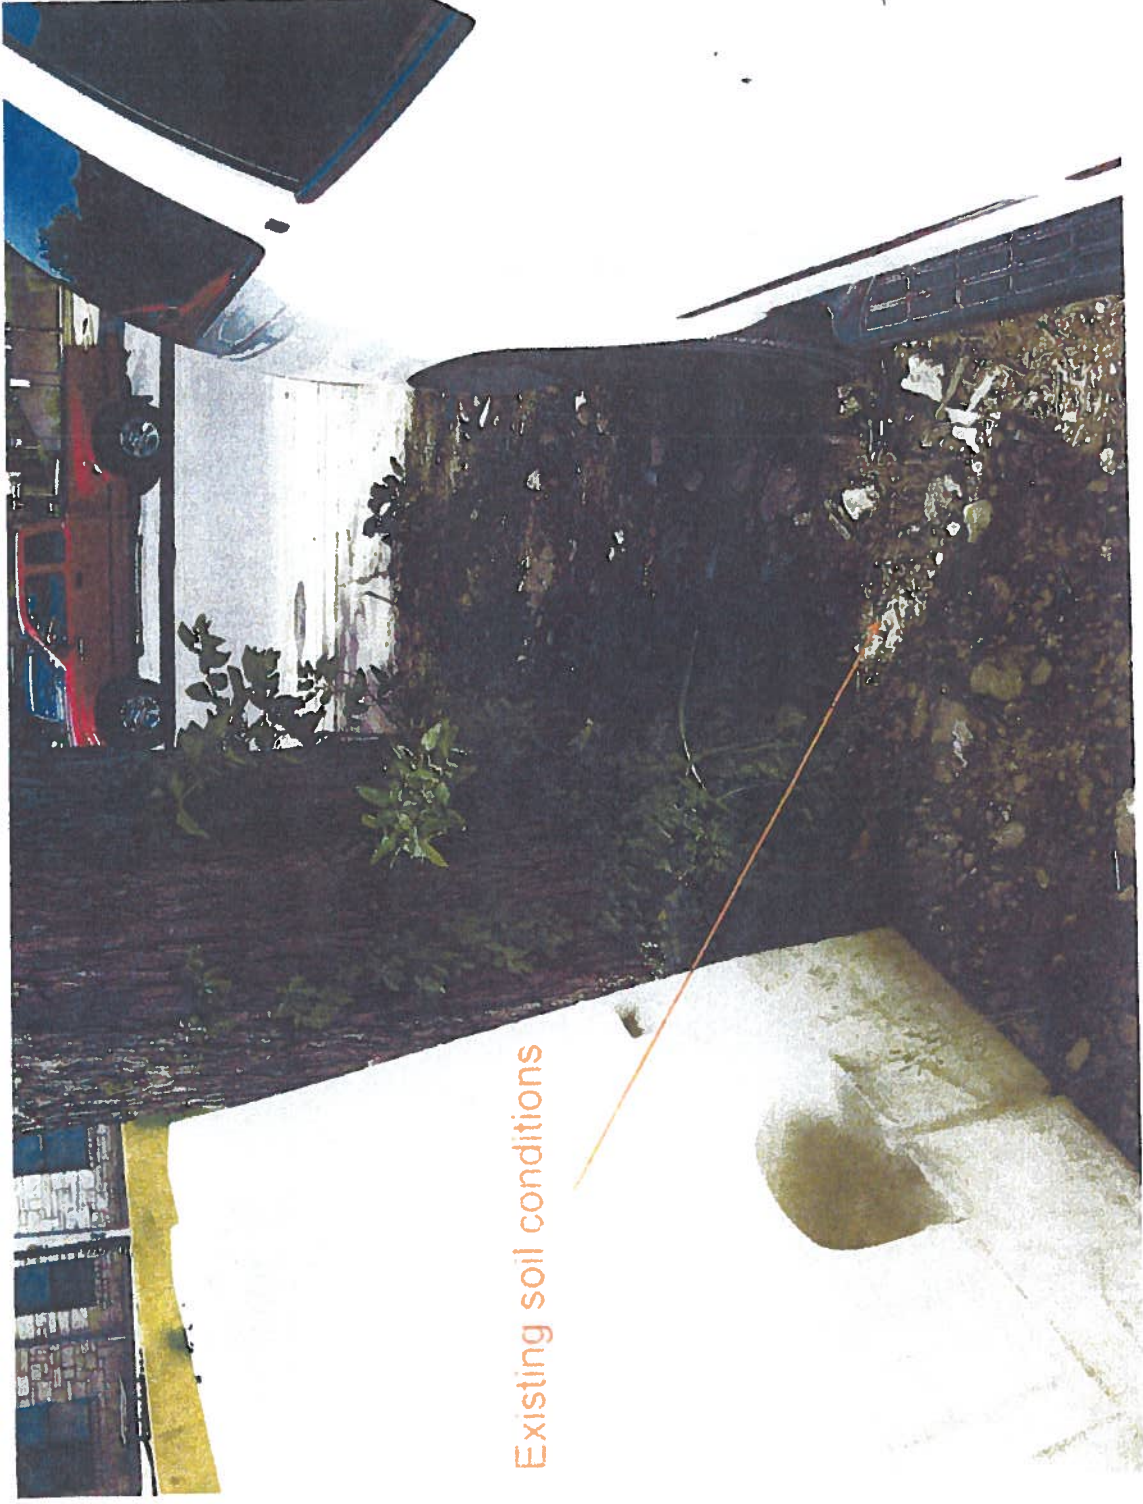
Exhibit #6

Existing soil conditions

- 300 percent mitigation.
- Applicant is to work with the Parks and Recreation Department to develop a tree care and/or tree planting program on public property within Shoal Creek Watershed.
- Tree care is provided by a certified arborist for the existing rights-of-way trees to remain onsite. Existing planter beds should also be expanded and soil conditions improved.
